# Manhole Inspection Summary

Manhole # S57C\_\_004MH

Insp Date: **3/4/09 1:41 PM**

**Location** Address: **4 n kresson st**

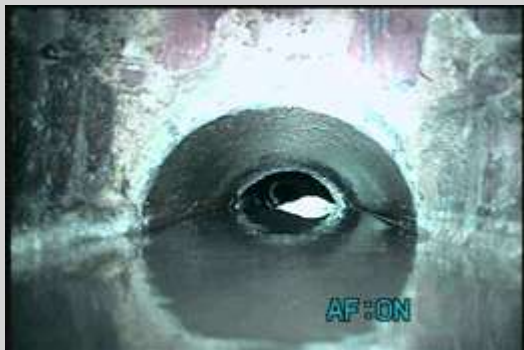
12 O'Clock Outflow

8 in. Circular Gravity Sewer  
Pipe Out @ 12 O'Clock

Pipe Material: **Clay** ☐ Pipe Lined

Invert Depth: **9.96** (ft.) Flow Characteristics: **None**

Deposits: ☒ None ☐ Mud ☐ Sludge ☐ Debris ☐ Grease

Infiltration: **None** Pipe Seal Cond: **Unknown**

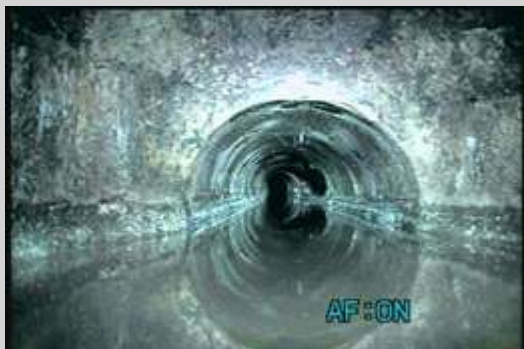
5 O'Clock Inflow

8 in. Circular Gravity Sewer  
Pipe In @ 5 O'Clock

Pipe Material: **Clay** ☐ Pipe Lined

Infiltration: **None** Pipe Seal Cond: **Unknown**
